INSPECTION REPORT: KENSINGTON GOLD MINE

Date of Inspection: Monday September 23, 2019
Date of Report: Monday October, 7 2019
USDA Forest Service Inspector: Richard Dudek

This inspection included the Access roads, Comet Development Pile, Comet Water Treatment Plant (CTWP), Sherman Creek Outfall 001, Pit 4, mud dump, the TTF area, and the fuel depot.

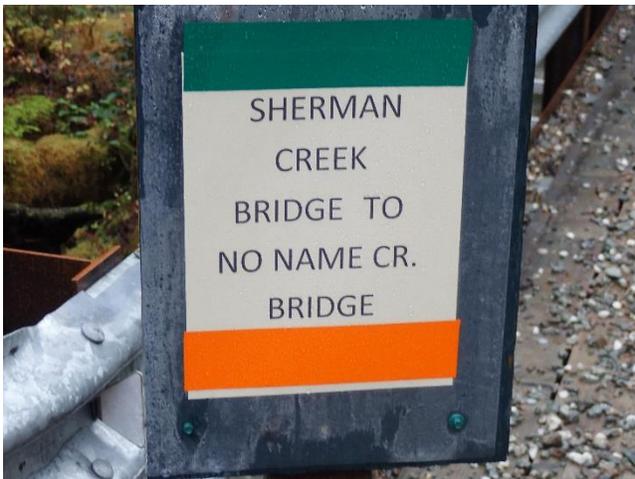
Photo 9. Formerly known as Upper Sherman Creek Bridge.

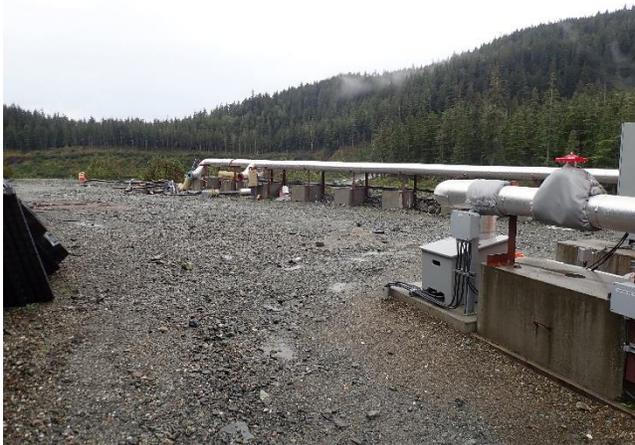
Photo 13. The location where the RO was located.

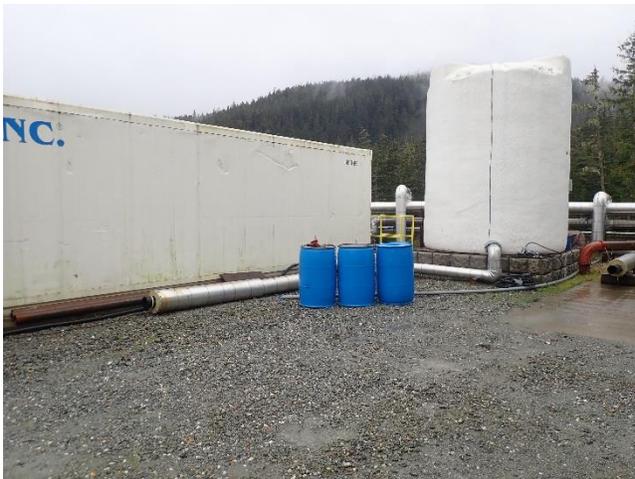
Photo 14. The site where the micro-filtration system was staged.

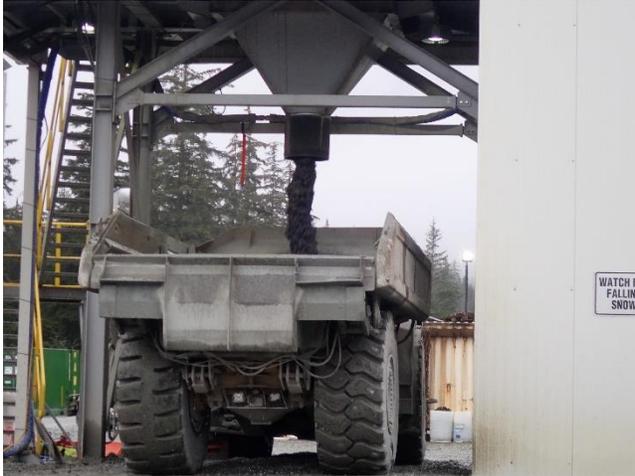
Coeur personnel continue to dispose of the graphitic phyllite (GP) as cemented underground backfill (Photo 17). Some ARD generation was observed on the liner for the GP stockpile. Coeur personnel were able to contain ARD and remove it immediately (Photos 18-19).

Photo 16. GP and cement mix for underground backfill.

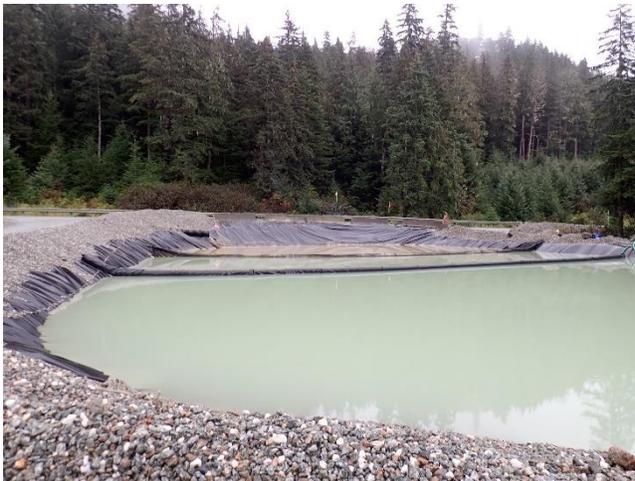
Storm water has accumulated underneath the HDPE liner for the GP stockpile. Environmental Operations is aware that water needs to be pumped out (Photo 20).

Photo 20. The mud dump settling pond.

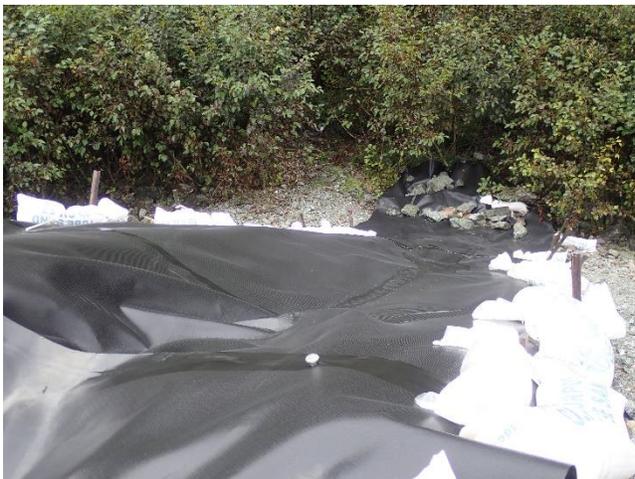
The settling ponds at this location are working as intended. Clear water observed discharging from the outlet pond and into the forest (Photos 21-22). This is the location where water is (Photo 23) pumped to the pug plant at Pit 4.

Photo 21. The outlet for the mud dump settling pond.

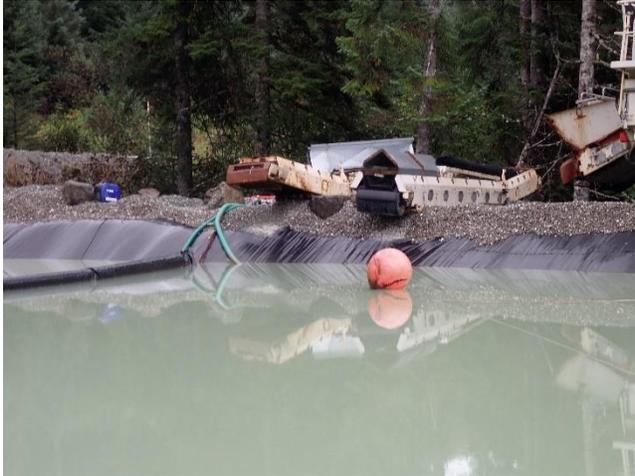
Photo 22. The float marker is the water withdrawal pump for the pug plant.

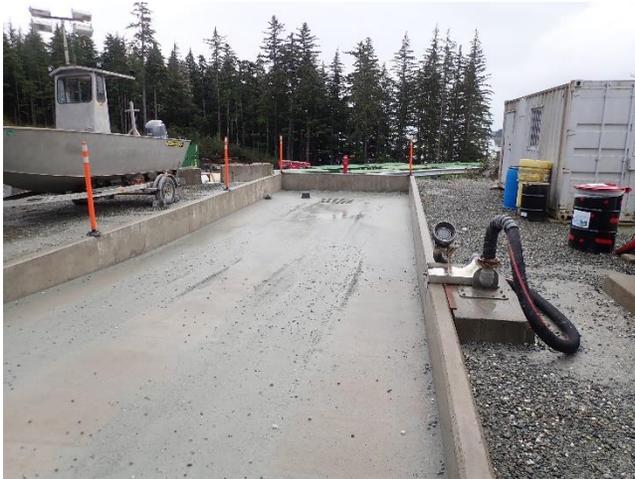
No fuel sheen and/or spills were observed in the fuel tanks gravel pad and at the refueling pad (Photos 23-24). Due to recent storm events, some water had pooled up in the southeast corner of the fuel tanks gravel pad (Photo 25). The fuel supply contractor also manages the water removal from the fuel tanks gravel pad.

Photo 23. The refueling pad.
